The Railway-Line Fence: A New Passive Elephant Barrier at Bannerghatta National Park, Southern India

We carried out a survey in the BNP from 8th July to 7th August 2017 to map land use patterns around the boundary, assess the efficacy of the railway line barriers and identify factors that potentially reduce their effectiveness.

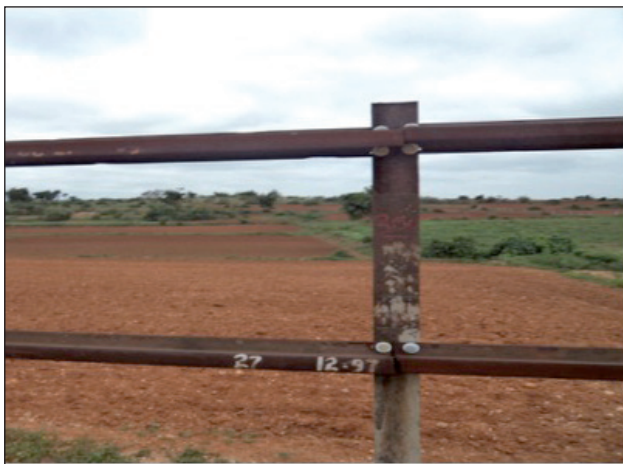
Figure 2. Horizontal bars are connected to the vertical bars with nuts and bolts.

Errors in construction of the rail barrier seemed to be considerably high. A total of 43 bolts connecting horizontal and vertical bars were missing, with 37 in Bannerghatta Range and 6 in Kodihalli Range. The soil below vertical bars

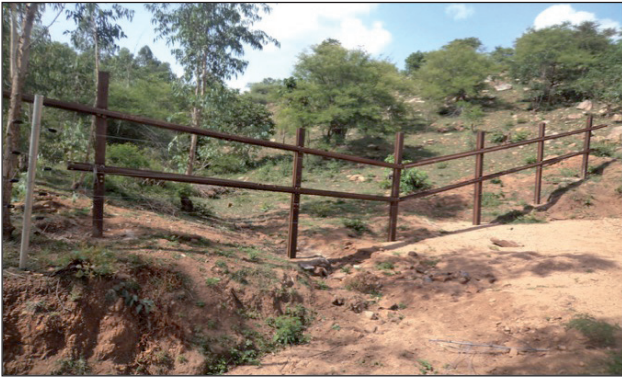
which 0.119 km was in the Gowdahalli beat and remaining 2.130 km in the Hanchuguli beat. The fence was continuous in Thattaguppe and Hanchuguli, however, in the Gowdahalli beat, the barriers were placed to supplement other barriers where there were water channels (Fig. 4). It was implemented as 4 different segments of 12 m, 30 m, 32 m and 45 m lengths.

Figure 4. Railway line barrier used for supplementing solar electric fence along water channels in Gowdahalli Beat, Kodihalli Range.

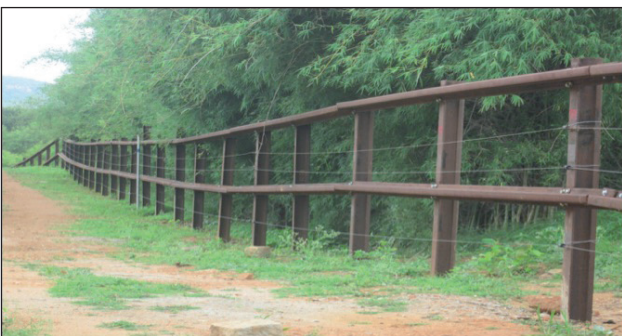
Figure 5. Railway line barrier with integrated electric fencing.

Solar electric fencing was found along 6 km of the rail barrier. We recorded a total of 11 breakages in solar electric fencing (10 in Kodihalli Range and 1 in Bannerghatta Range). In Kodihalli, fencing was broken by elephants, amounting to a damage extent of 1.0 km. The fence was broken by humans at 9 locations, for facilitating the movement of cattle and fuel wood collection. A 5 km length of the rail barrier had an integrated solar electric fence, which did not have any breakages (Fig. 5).

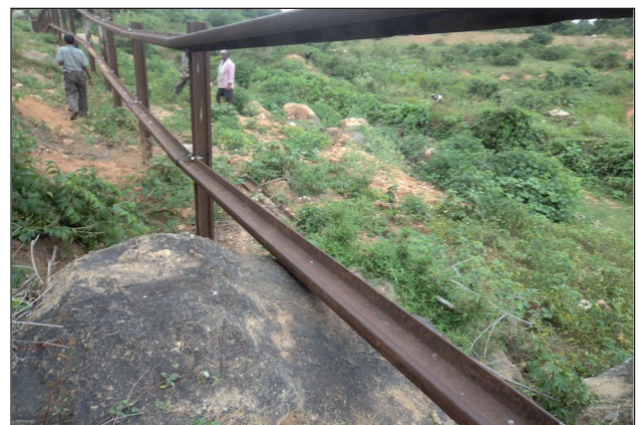
Figure 6. A boulder that possibly decreases the effectiveness of the railway line barrier.

was found to be eroded extending to about 15 to 40 cm, at 5 places, 4 in Bannerghatta Range and 1 in Kodihalli. Boulders were found at the barrier on 5 locations in Bannerghatta Range (Fig. 6).
